PRELIMINARY VIBRATION AND FLUTTER STUDIES ON P-47 TAIL

By Theodore Theodorsen

Langley Memorial Aeronautical Laboratory
Langley Field, Va.

MEMORANDUM REPORT

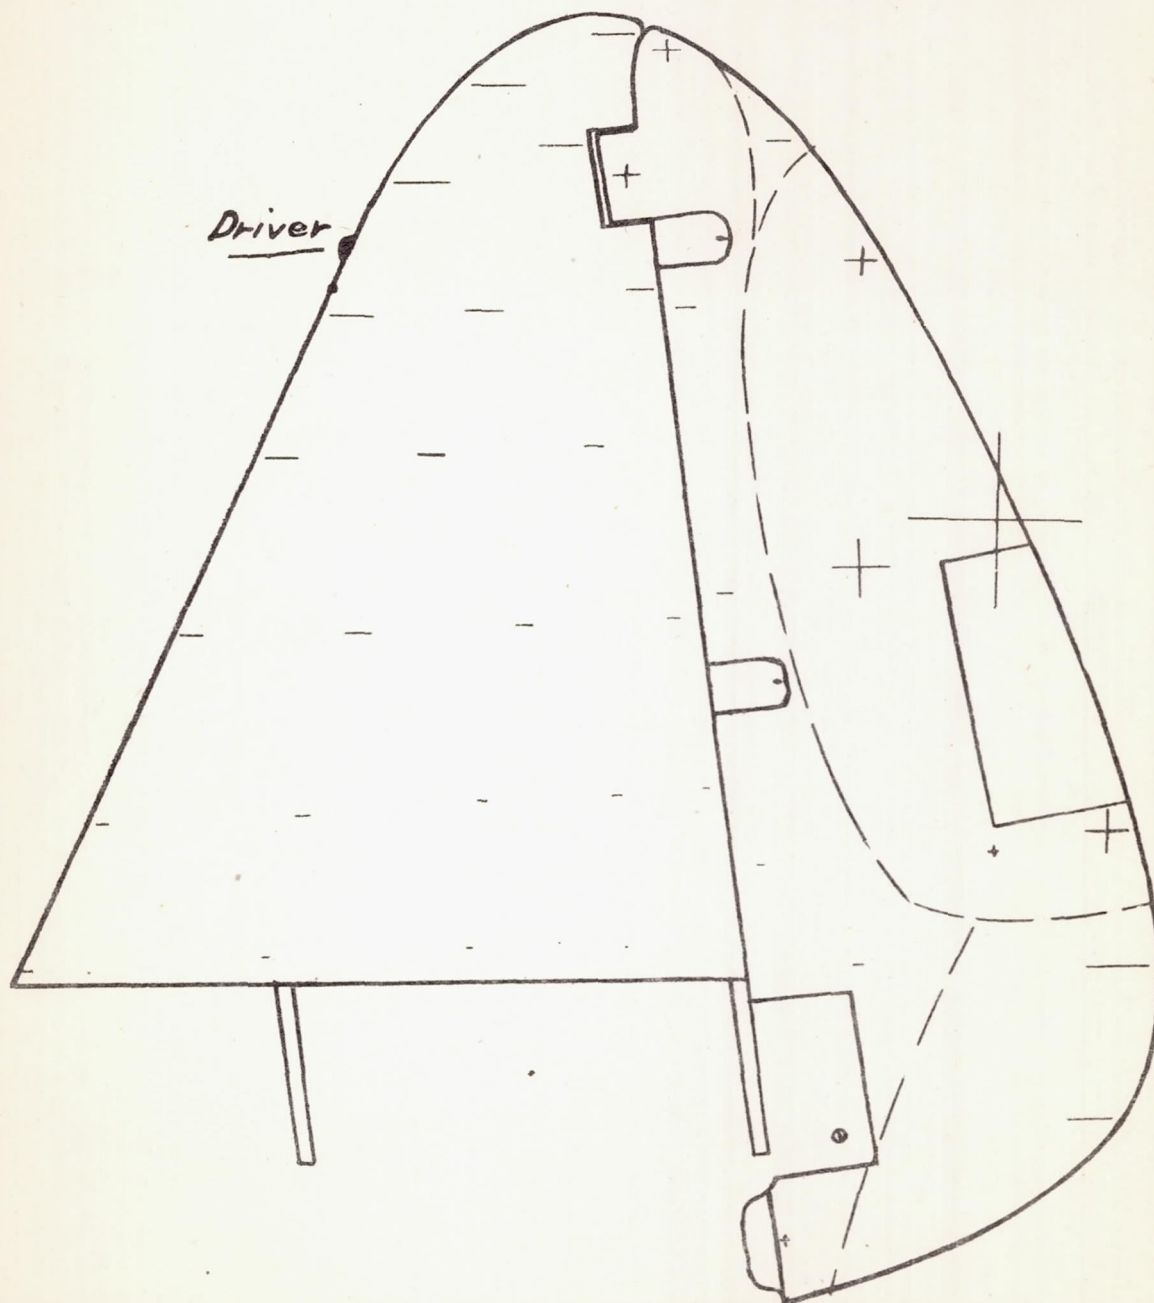
FIGURE 4.

In the next figure (fig. 4), which case was originally believed susceptible to flutter, it is seen that there is a large deflection near the upper end of the tab. The top balancing weight is out of phase. Responses at 75 and 94 cycles per second were also recorded. (See figs. 5 and 6.)

a higher mode of the type shown in figure 4 was involved. The studies showed that not much margin of safety remained against flutter in this mode. Since the records give no evidence of this mode of a frequency of 50 to 60 cycles per second, but showed a higher mode of 146 cycles per second, detail reference to these calculations will be considered unnecessary at the present stage.

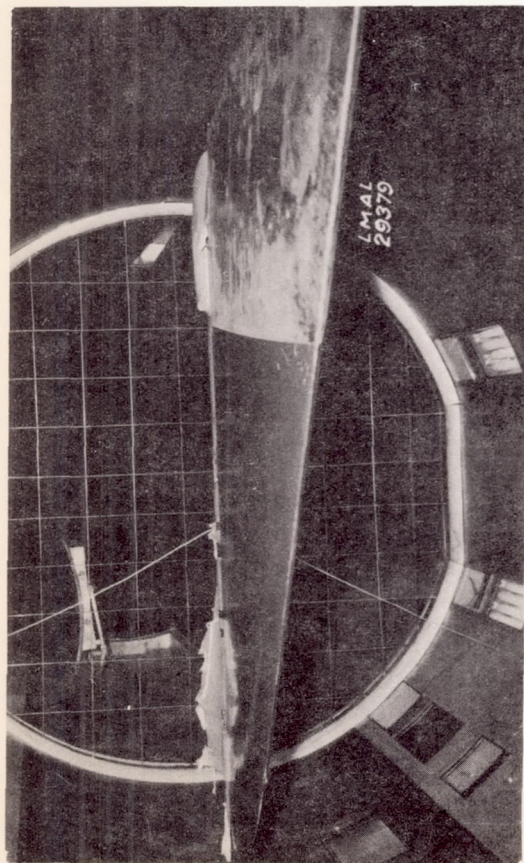
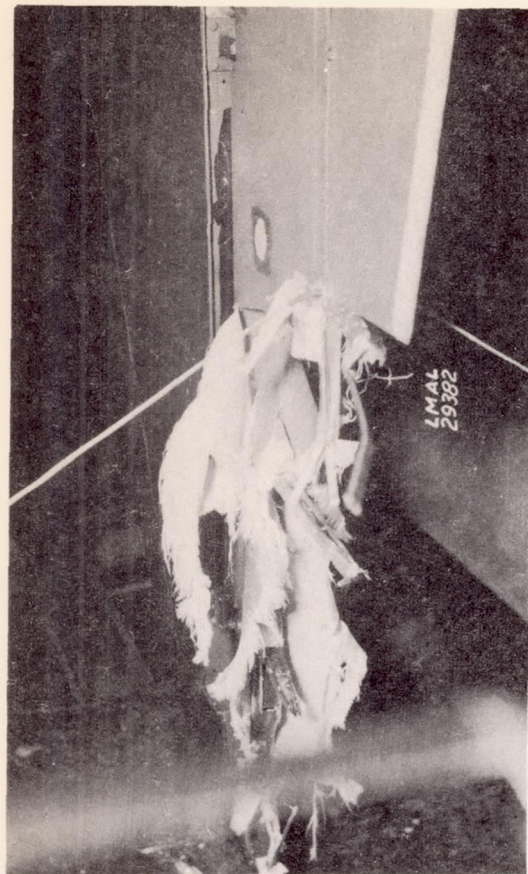
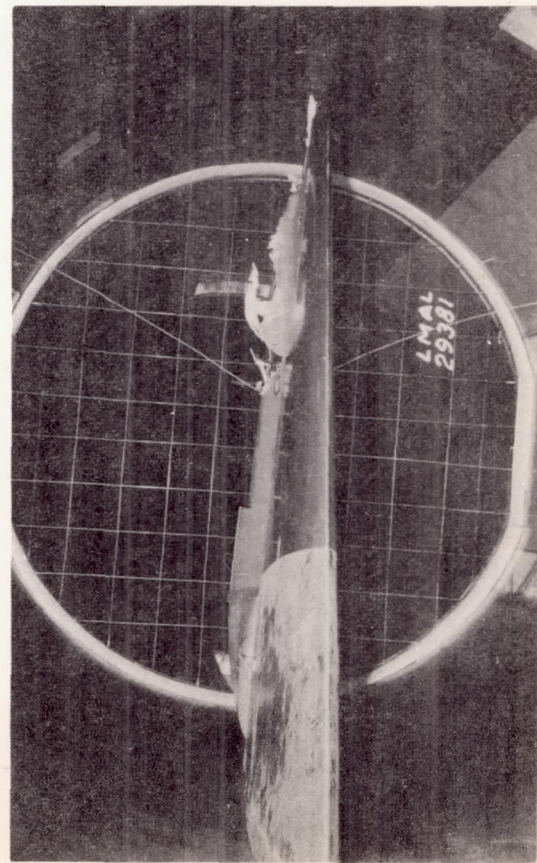
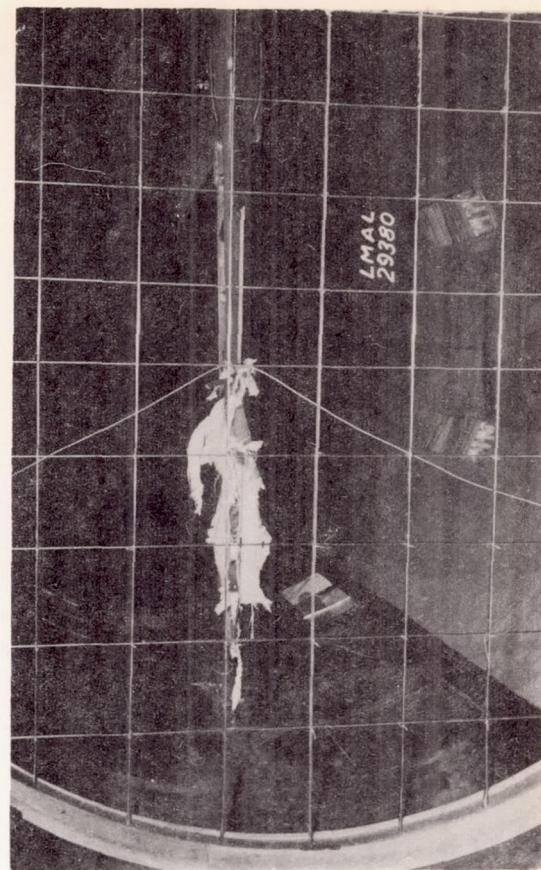
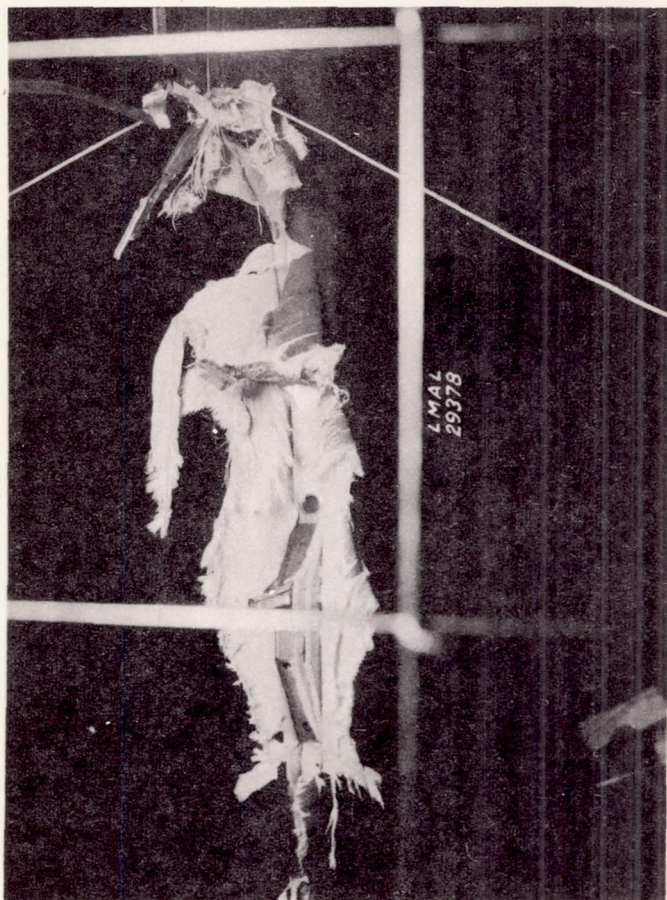
The rudder failed at 468 miles per hour (true speed). The temperature of the air was $t = 111^{\circ} \text{F}$ and the density $\rho = 0.00182$ pounds per cubic foot. The upper portion of the rudder beyond the tab was demolished, the trailing edge and most of the fabric torn off, and the ribs badly twisted with the upper one torn out. The act of disintegration of the rudder was observed by several persons. It did not appear to be violent probably due to the high frequency involved. Prior to the explosion the rudder appeared rather normal except for a distinct swelling up of the skin between the ribs, most prominent near the base but also evident over the front portion of the tip of the rudder. This swelling started at about 300 miles per hour. The installation was not conveniently arranged for visual observation. Evidently the entire upper section of the rudder swelled up considerably a few seconds before the final destruction. Whether the structure at this time exhibited a possible large amplitude and high frequency vibration, or that it already had broken down, was not evident from observation. The process of destruction lasted only 3 to 5 seconds. The photographs

(fig. 7 through 11) show the destroyed rudder in the tunnel, and figure 12, the rudder separately with the broken pieces of the trailing edge arranged in place by small wires.

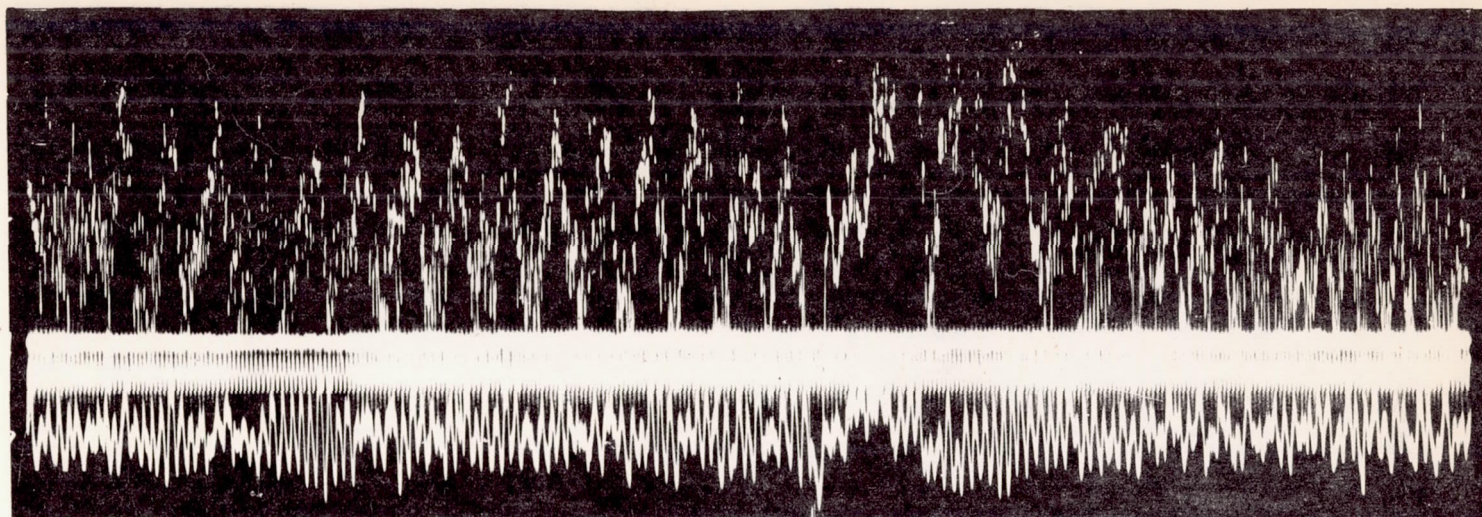
Figure 29.

At approximately 400 miles per hour, there are four to five large peaks appearing in the fin-bending record, G, and evidently similar disturbances in the other three. In other words, the damping is starting to disappear, which fact is significant of the approach to a condition of flutter involving these particular responses. However, flutter in these combinations of lower frequency modes evidently did not develop. It is noted that at about 420 miles per hour (fig. 27) a very high frequency of about 140 cycles per second comes into evidence. At 440 miles per hour (fig. 28) the damping in the low bending appears fairly unchanged but the high frequency of about 140 cycles per second starts to dominate the record.

This high frequency was in evidence probably for 3 to 5 minutes before the failure of the rudder. The final record (fig. 30) was taken at approximately 468 miles per hour true speed (or 410 indicated) about a minute before the rudder was destroyed. It is seen that the element, B, which was situated near the center of the destroyed area, shows an almost pure sine wave. The frequency is by count 146 cycles per second.

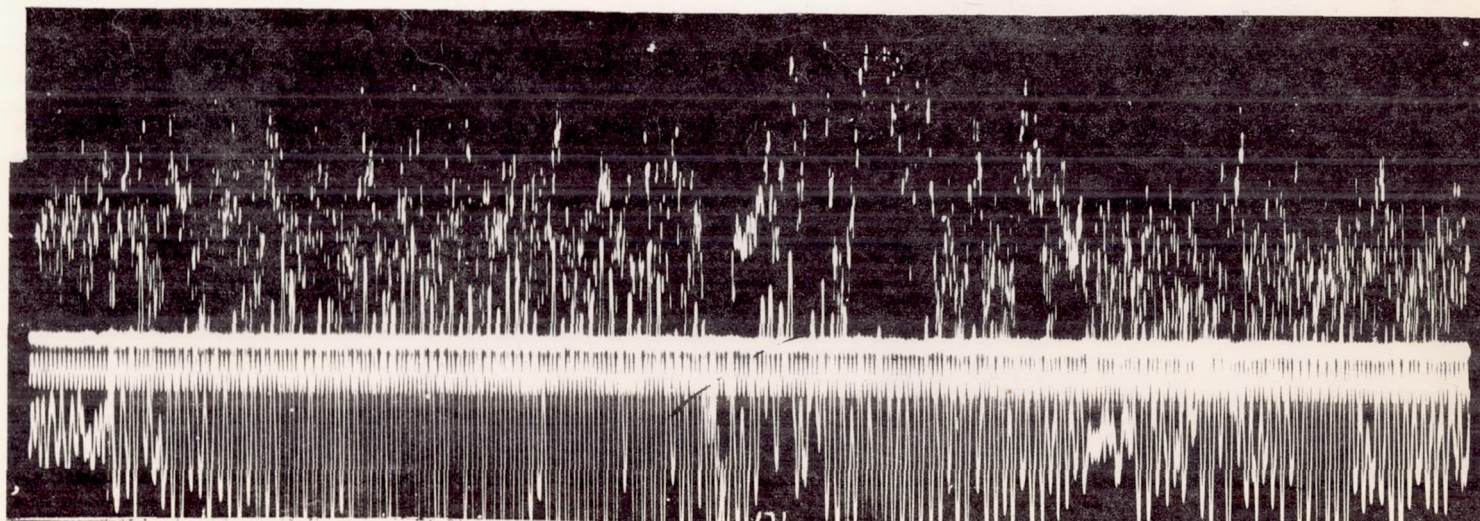
Figure 30.

Airspeed near top speed (approx. 468 mph).

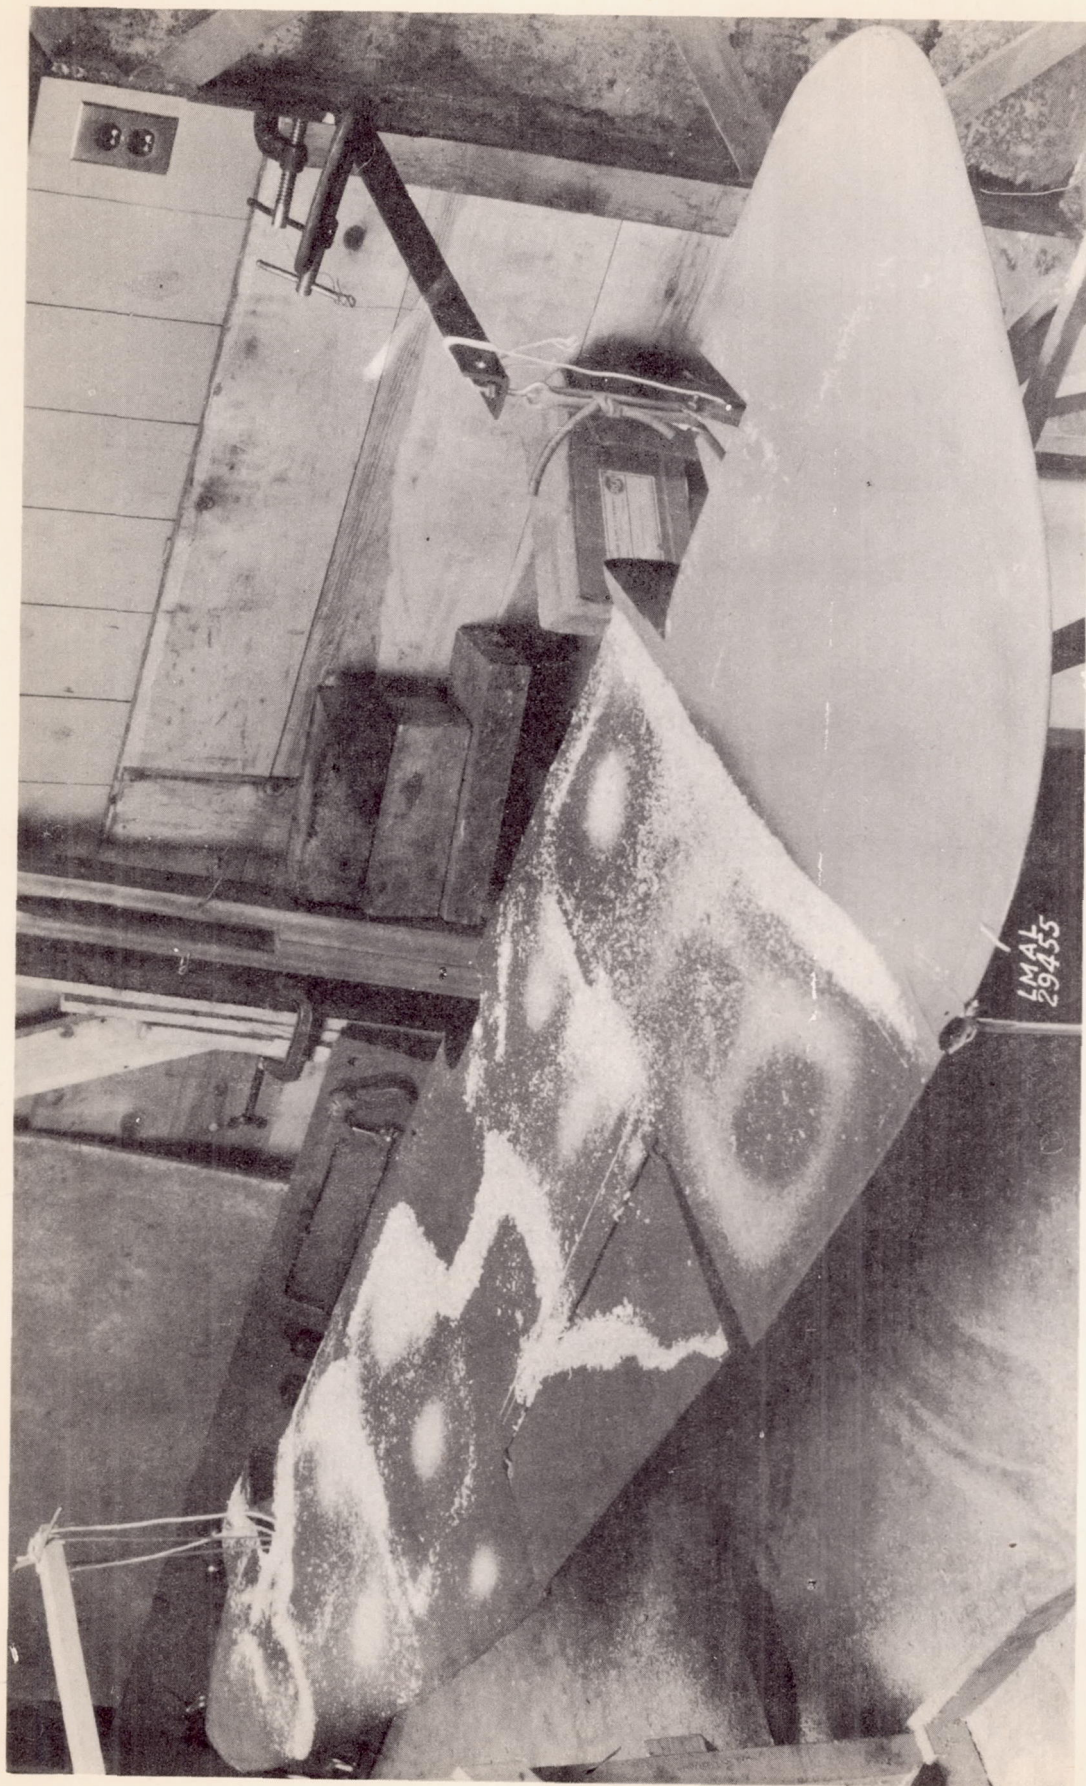
Figure 31.

Since the frequency observed in the records of the rudder failure was much higher than the one previously assumed capable of producing flutter, a prototype of the destroyed rudder was subjected to further vibration studies since these high frequencies were not investigated in advance. This high frequency was located at 138 cycles per second and is shown in saw-dust pattern in figure 31. Like most of the higher-mode responses, it cannot conveniently be identified by a simple term.

It might be designated a trailing-edge response since the motion involved deflection of the trailing edge which assumed a sine form with less deflections near the rib attachments. The ribs exhibited essentially pure torsion. The fabric would assume certain square response patterns. The regularity of the pattern was somewhat broken by the tab. The tab free or fixed to the rudder would only change the frequency by a few percent.
